To the Voters of the Town of Bridgewater:

The following is a summary regarding the future of the school building. Recall, that a survey was sent out about the possibilities. The responses and options are listed below. The town has received reports from a realtor and an engineering firm. These reports are available for your inspection at the Town Office. 142 people responded to the survey.

Summary

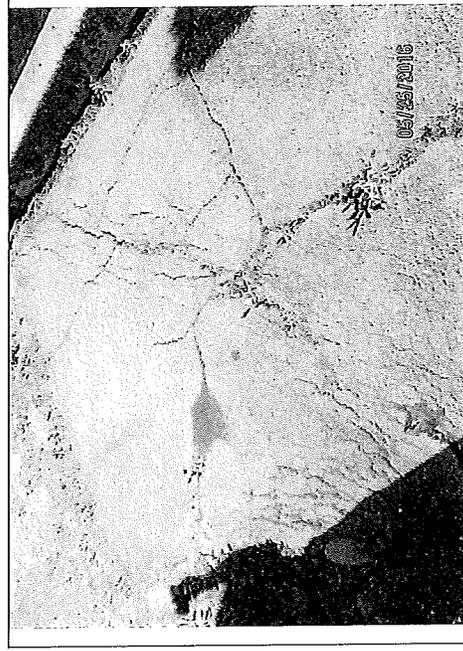
Description:
Deterioration in front
walkway

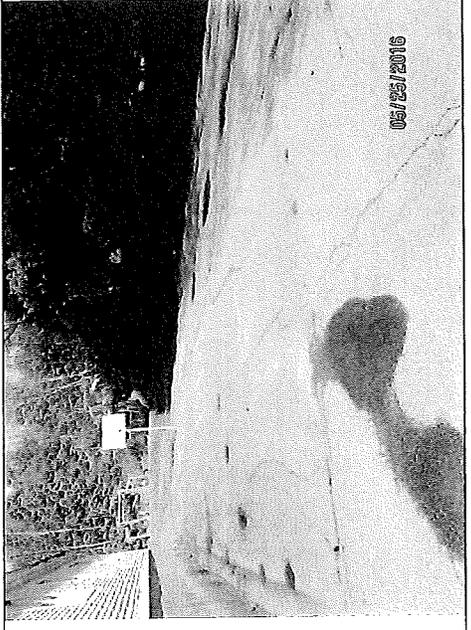
Along the east side of the building, the asphalt is in fair to poor condition. There is evidence of cracking and settlement and repairs should be anticipated.

Description:
 Deterioration of paving at right side of building

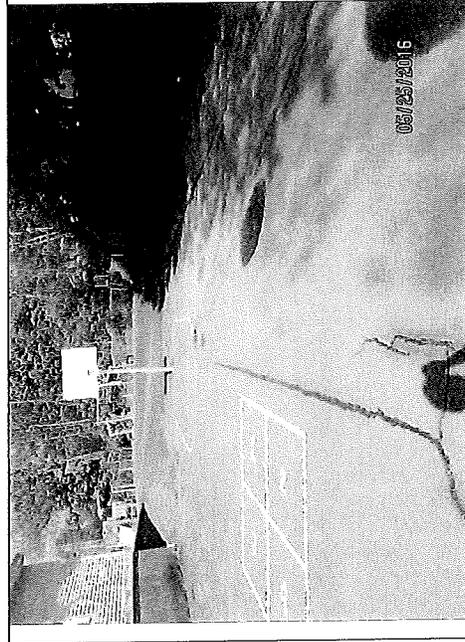
There is a paved recreation area at the rear of the building. This paving is in fair to poor condition with cracking and settlement noted. Repair or replacement is needed.

Description:
 Deterioration of paving at rear recreation area

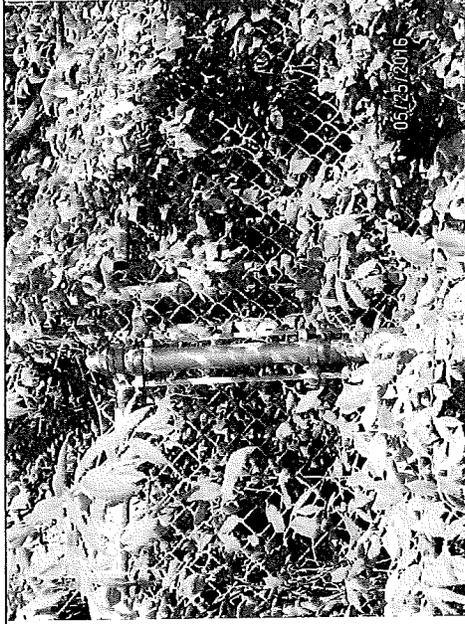
There is a play area at the west side of the building which is enclosed by a six foot high chain link fence. This fencing is in fair condition. Portions are damaged and leaning. Repair is needed at this time.

Description:
Fence repair needed

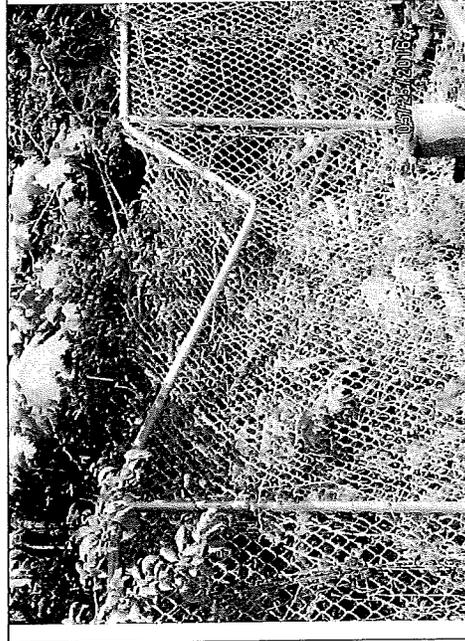
Description:
Fence repair needed

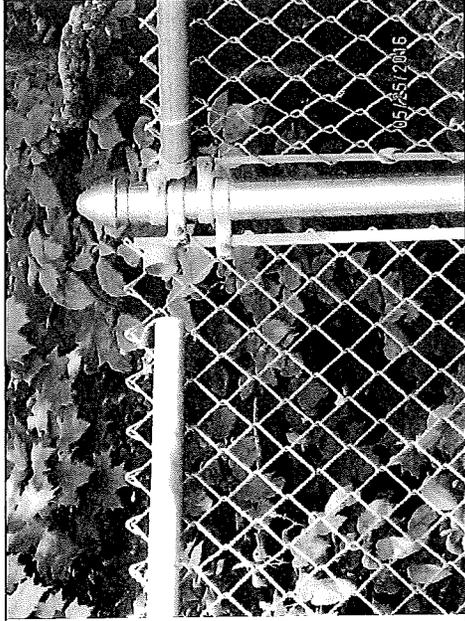
Description:
Fence repair needed

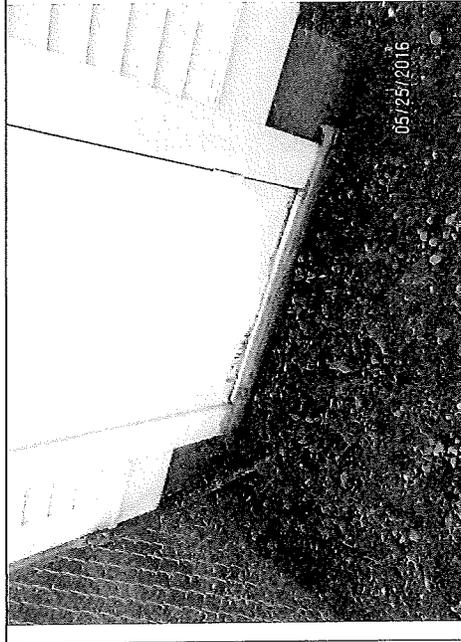
Description:
Deteriorated roofing at
right bulkhead entry

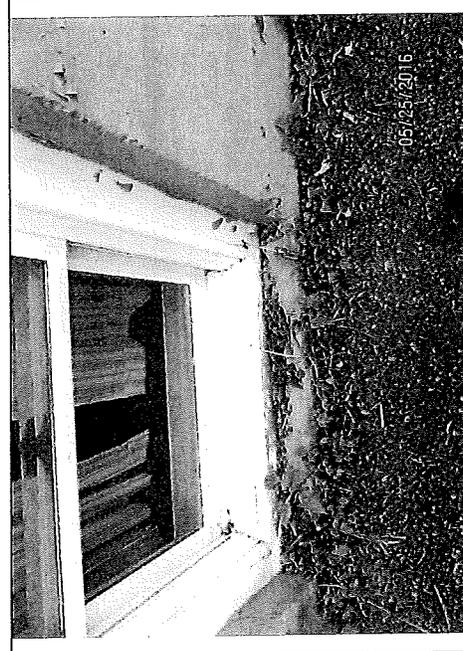
Evidence of rot and deterioration was noted in the trim at the front basement windows. This rot and deterioration may extend into the structural framing in this area. The full extent of this condition could not be determined at the time of inspection. These areas should be opened for further investigation and the proper repairs be made.

<p>Location: 7313 US Route 4 Bridgewater, VT</p> <p>Photo Taken By: Richard Lalancette, P.E.</p> <p>IMG: 1884</p> <p>Description: Rot in trim at front basement windows</p>

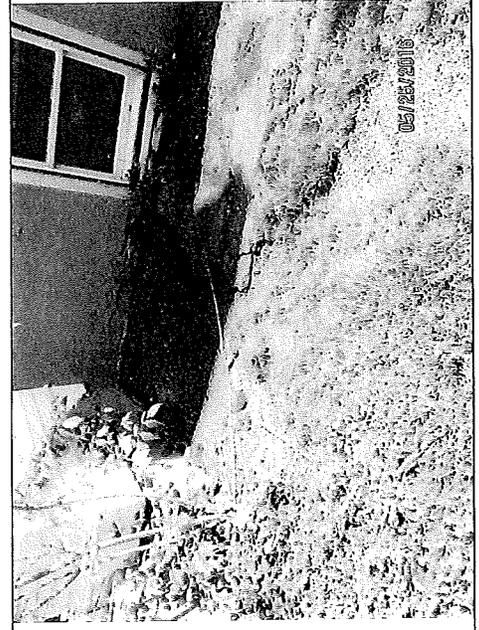
<p>Location: 7313 US Route 4 Bridgewater, VT</p> <p>Photo Taken By: Richard Lalancette, P.E.</p> <p>IMG: 1887</p> <p>Description: Deteriorated drainage paving at front of building</p>

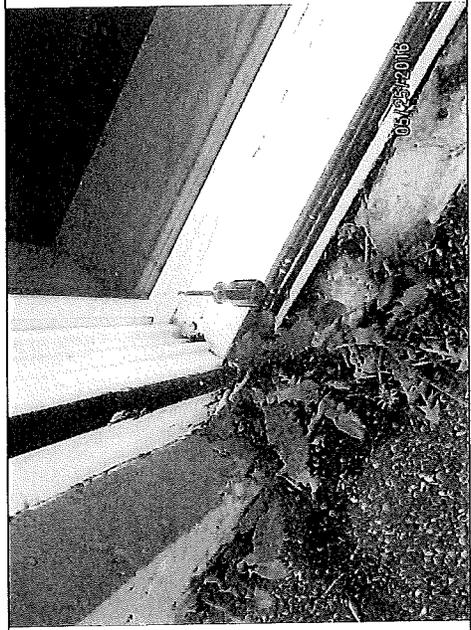
Description:
Rot in window sash

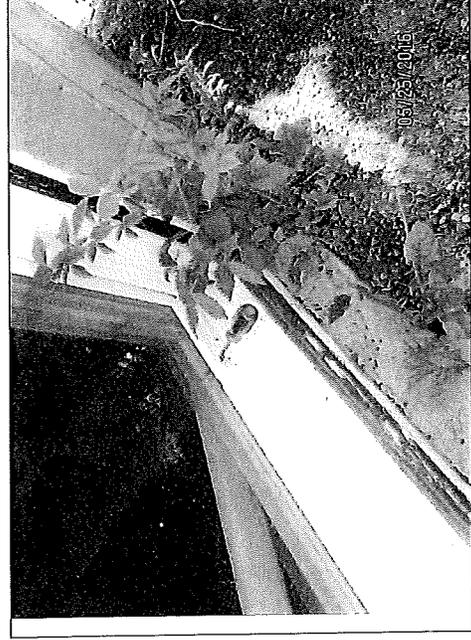
Description:
Rot in window sash

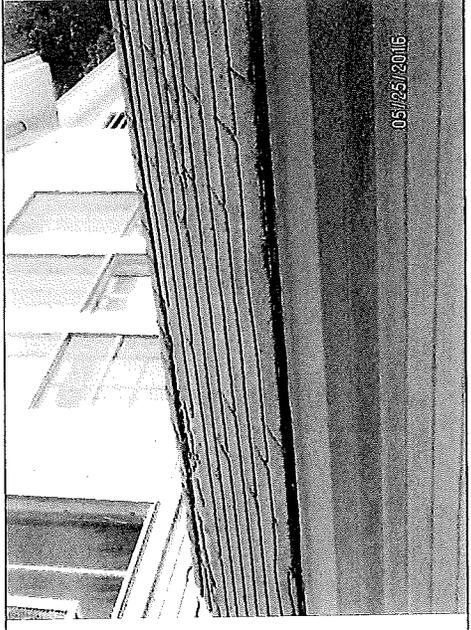
Description:
Rot in window sash

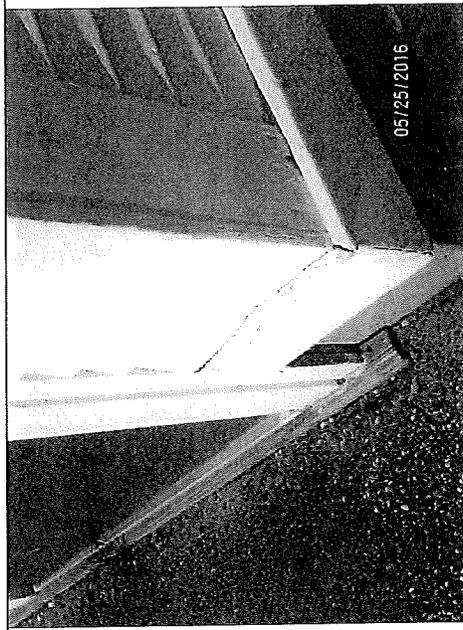
Description:
 Right bulkhead roof in
 poor condition

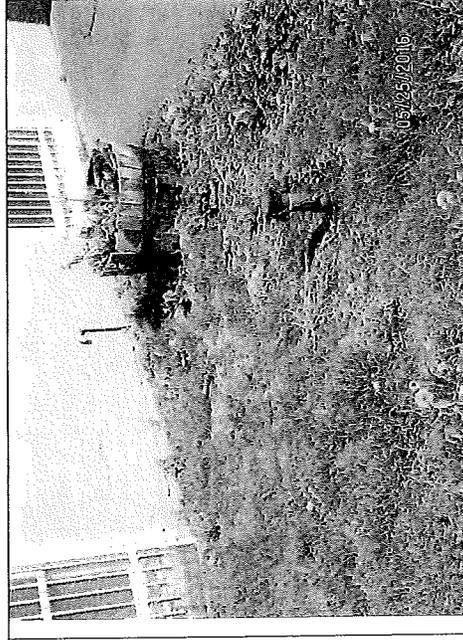
Description:
 Cracked lower trim at
 right entry

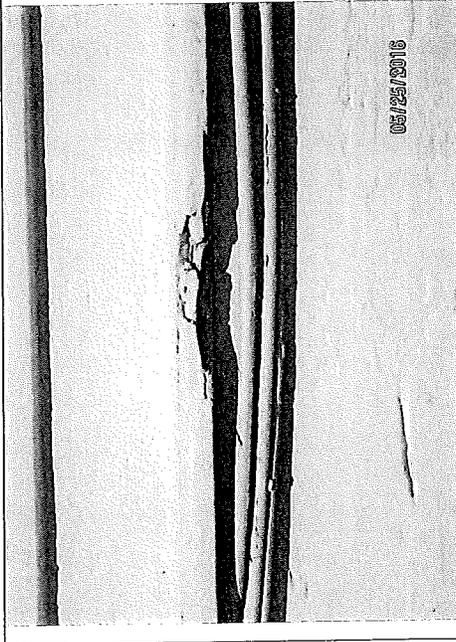
<p>05/25/2016</p>	<p><u>Location:</u> 7313 US Route 4 Bridgewater, VT</p> <p><u>Photo Taken By:</u> Richard Lalancette, P.E.</p> <p><u>IMG:</u> 1897</p> <p><u>Description:</u> Deteriorated trim</p>

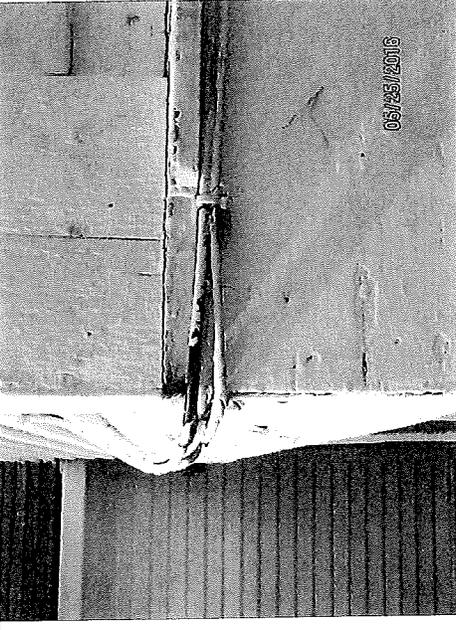
<p>05/25/2016</p>	<p><u>Location:</u> 7313 US Route 4 Bridgewater, VT</p> <p><u>Photo Taken By:</u> Richard Lalancette, P.E.</p> <p><u>IMG:</u> 1898</p> <p><u>Description:</u> Deteriorated trim</p>
---	---	--	---

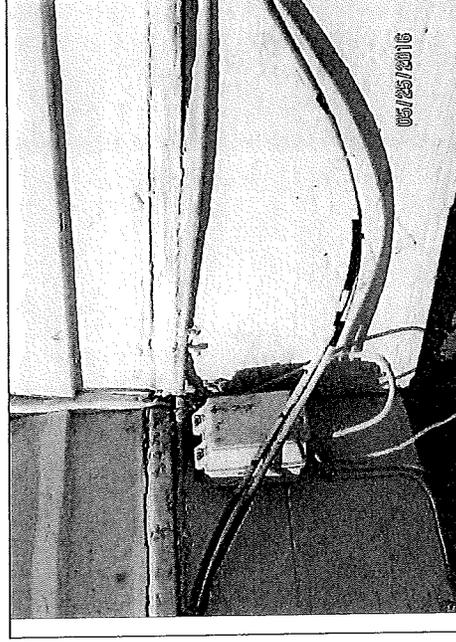
<p>05/25/2016</p>	<p><u>Location:</u> 7313 US Route 4 Bridgewater, VT</p> <p><u>Photo Taken By:</u> Richard Lalancette, P.E.</p> <p><u>IMG:</u> 1899</p> <p><u>Description:</u> Deteriorated trim</p>

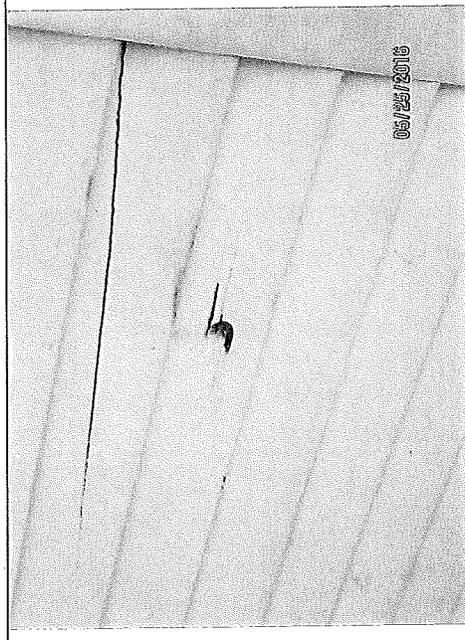
Description:
Cracked lower trim

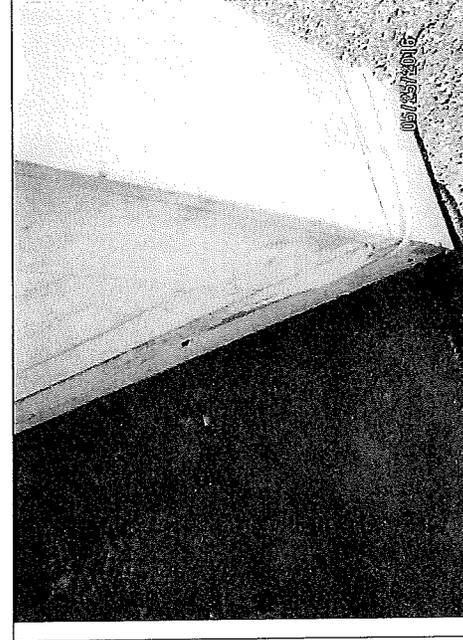
Description:
Siding repair needed by
right rear entry

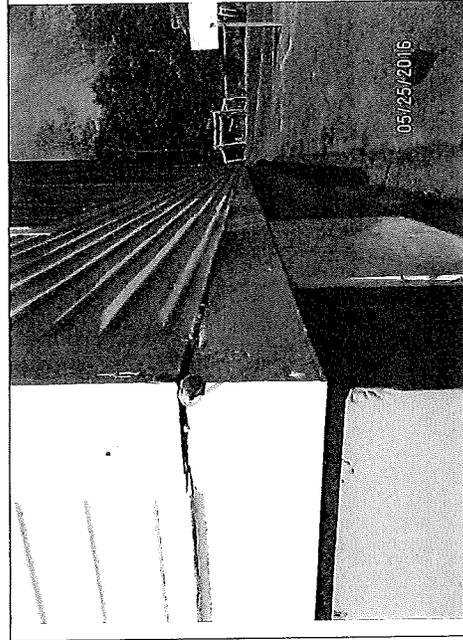
Description:
Deteriorated lower trim

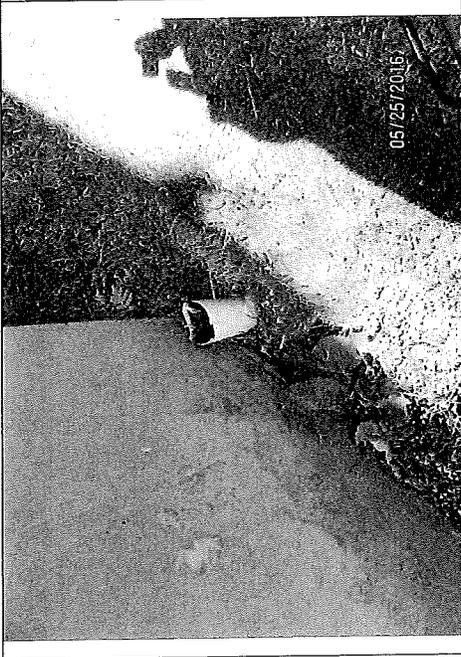
Description:
Deteriorated drip edge
at rear of building

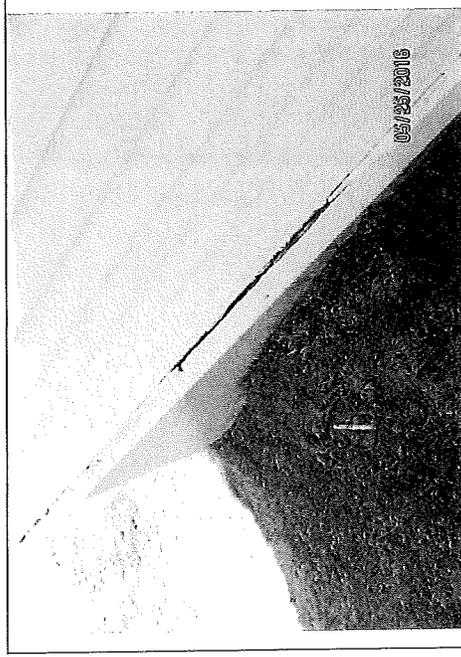
<p>05/25/2016</p>	<p>Location: 7313 US Route 4 Bridgewater, VT</p> <p>Photo Taken By: Richard Lalancette, P.E.</p> <p>IMG: 1907</p> <p>Description: Damaged lower trim at left rear of building</p>

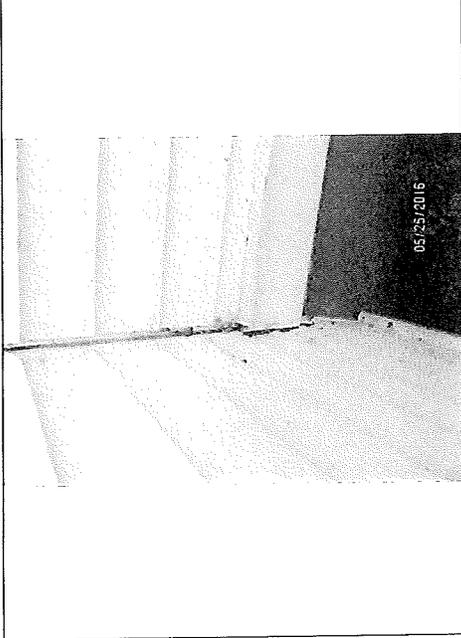
<p>05/25/2016</p>	<p>Location: 7313 US Route 4 Bridgewater, VT</p> <p>Photo Taken By: Richard Lalancette, P.E.</p> <p>IMG: 1908</p> <p>Description: Left rear entry has heaved and settled</p>

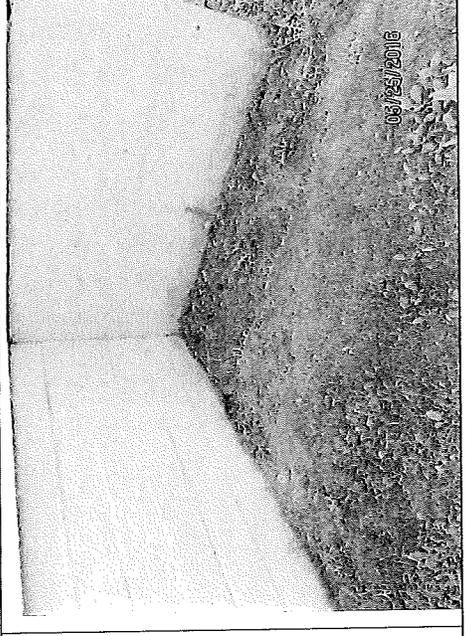
Some cracking of the concrete foundation walls was noted in the front basement area. The full extent of this cracking could not be determined due to the finishes in this area.

Description:
 Crack in foundation at
 left rear of building

The cracks in the foundation walls, both inside and outside, should be properly repaired. Sealing these cracks will help to prevent moisture penetration/leakage and will help to prevent them from getting larger.

One of the better ways to seal these cracks is from the outside. First, chip a v-groove in the concrete along the length of the crack (all the way to the footing, if necessary). The root of this v-groove should then be filled with a high-quality caulking (epoxy, latex, or polyurethane), mortar applied to fill the groove, and, finally bituminous basement waterproofing applied.

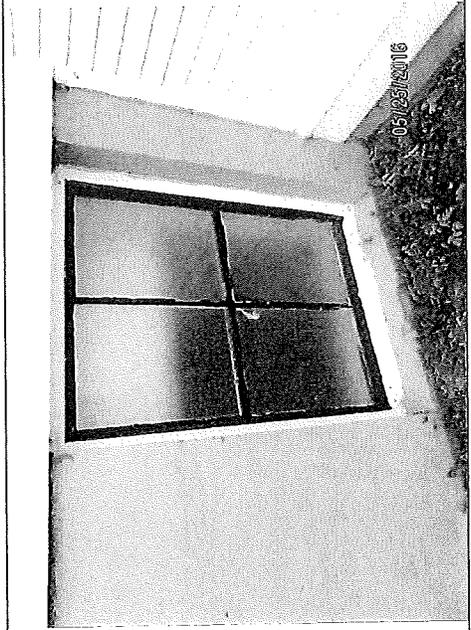
Description:
 Basement window in
 poor condition / No
 storm window

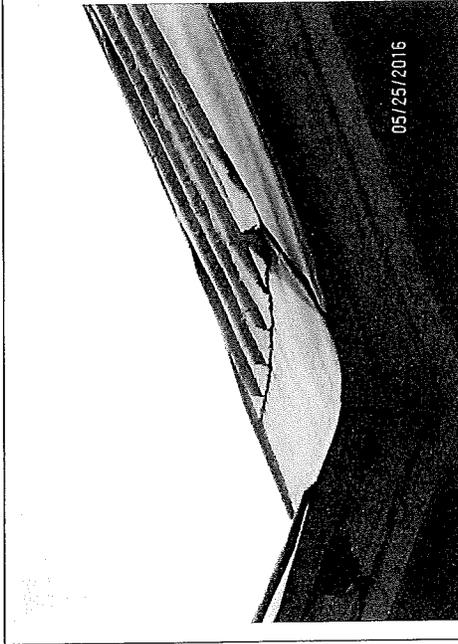
<p><u>Location:</u> 7313 US Route 4 Bridgewater, VT</p> <p><u>Photo Taken By:</u> Richard Lalancette, P.E.</p> <p><u>IMG:</u> 1931</p> <p><u>Description:</u> Roof repair needed at front valley</p>

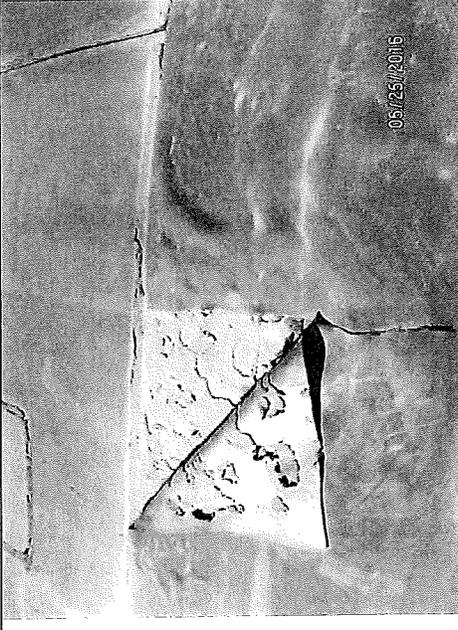
<p><u>Location:</u> 7313 US Route 4 Bridgewater, VT</p> <p><u>Photo Taken By:</u> Richard Lalancette, P.E.</p> <p><u>IMG:</u> 1932</p> <p><u>Description:</u> Seam opening on rear membrane roof</p>
---	--	--	--

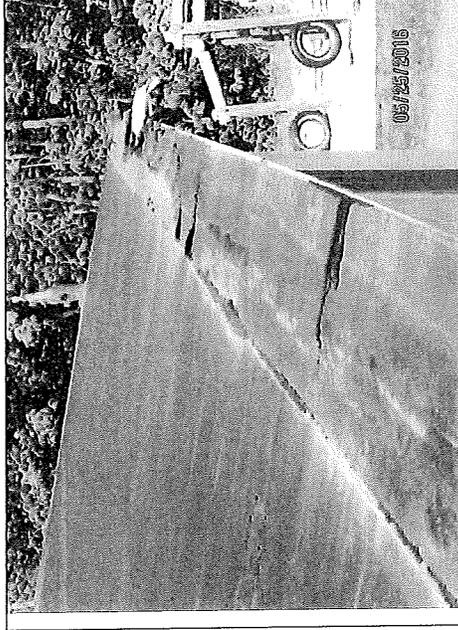
<p><u>Location:</u> 7313 US Route 4 Bridgewater, VT</p> <p><u>Photo Taken By:</u> Richard Lalancette, P.E.</p> <p><u>IMG:</u> 1934</p> <p><u>Description:</u> Rear membrane roof in poor condition</p>
--	--	---	--

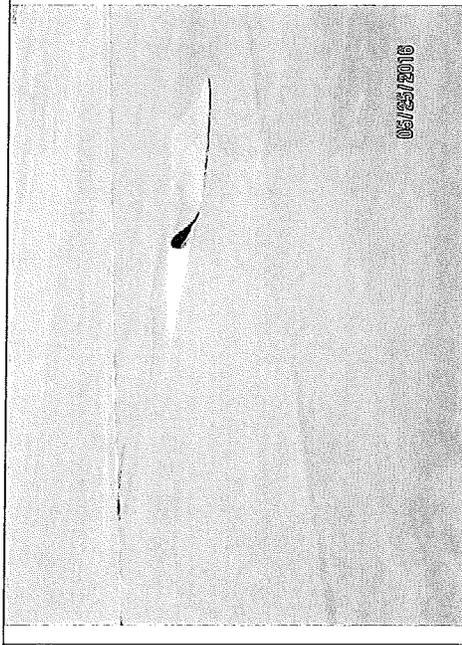
Description:
Loose patch at rear
membrane roof

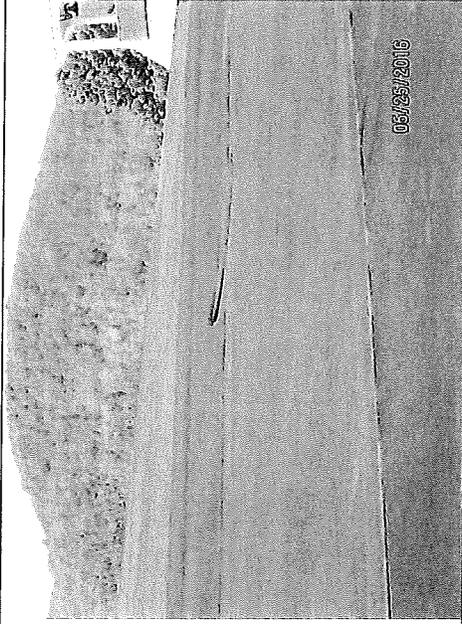
Description:
Loose patch at rear
membrane roof

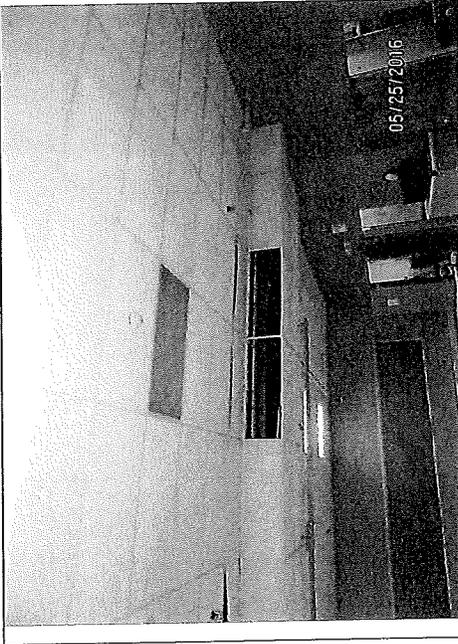
<p><u>Location:</u> 7313 US Route 4 Bridgewater, VT</p> <p><u>Photo Taken By:</u> Richard Lalancette, P.E.</p> <p><u>IMG:</u> 1940</p> <p><u>Description:</u> Tile repair needed at multipurpose room</p>

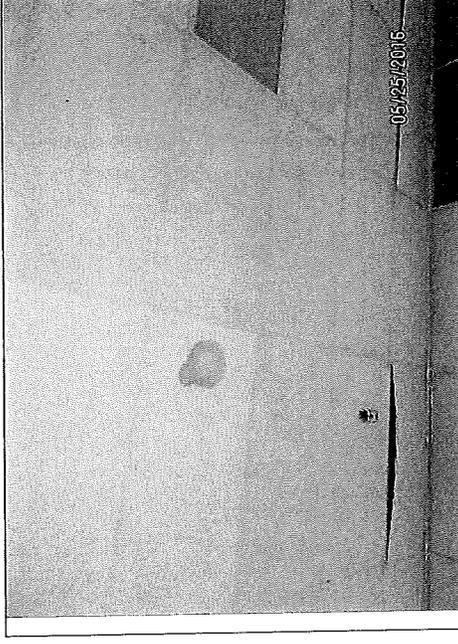
<p><u>Location:</u> 7313 US Route 4 Bridgewater, VT</p> <p><u>Photo Taken By:</u> Richard Lalancette, P.E.</p> <p><u>IMG:</u> 1942</p> <p><u>Description:</u> Leakage on ceiling at multipurpose room</p>

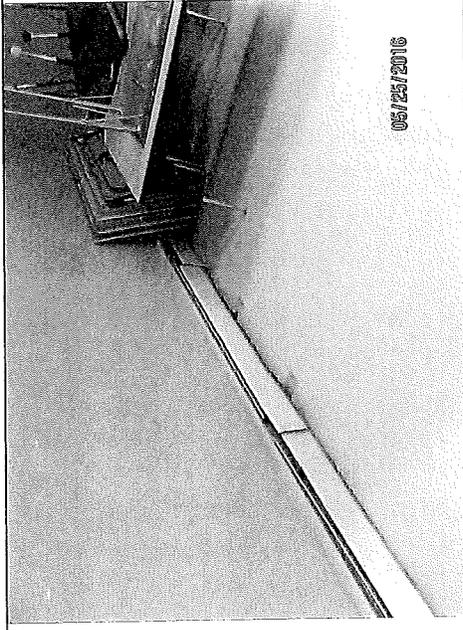
Various baseboard heating unit enclosure repairs throughout the building are needed.

<p>05/25/2016</p>	<p><u>Location:</u> 7313 US Route 4 Bridgewater, VT</p> <p><u>Photo Taken By:</u> Richard Lalancette, P.E.</p> <p><u>IMG:</u> 1949</p> <p><u>Description:</u> Baseboard enclosure repair needed</p>

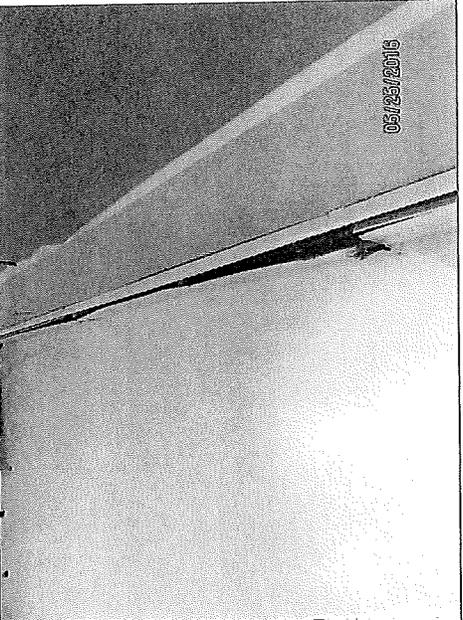
<p>05/25/2016</p>	<p><u>Location:</u> 7313 US Route 4 Bridgewater, VT</p> <p><u>Photo Taken By:</u> Richard Lalancette, P.E.</p> <p><u>IMG:</u> 1950</p> <p><u>Description:</u> Baseboard enclosure repair needed</p>

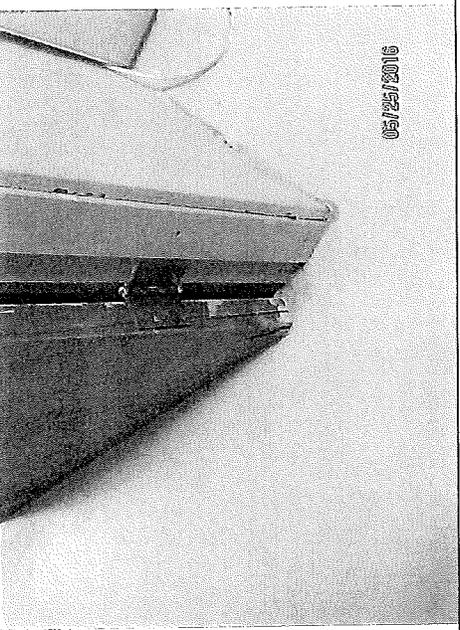
<p><u>Location:</u> 7313 US Route 4 Bridgewater, VT</p> <p><u>Photo Taken By:</u> Richard Lalancette, P.E.</p> <p><u>IMG:</u> 1954</p> <p><u>Description:</u> Deteriorated door</p>

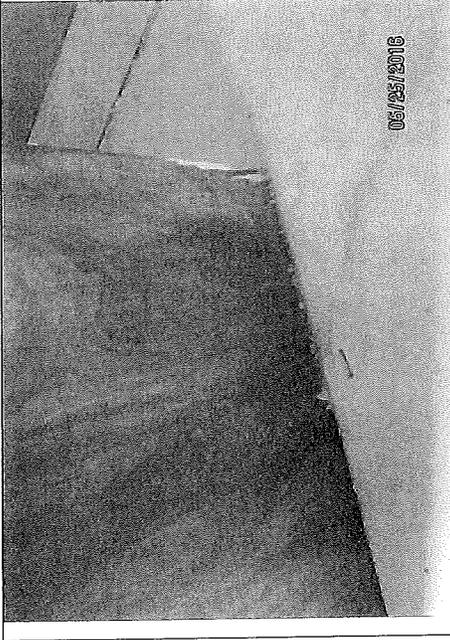
<p><u>Location:</u> 7313 US Route 4 Bridgewater, VT</p> <p><u>Photo Taken By:</u> Richard Lalancette, P.E.</p> <p><u>IMG:</u> 1955</p> <p><u>Description:</u> Deteriorated door</p>

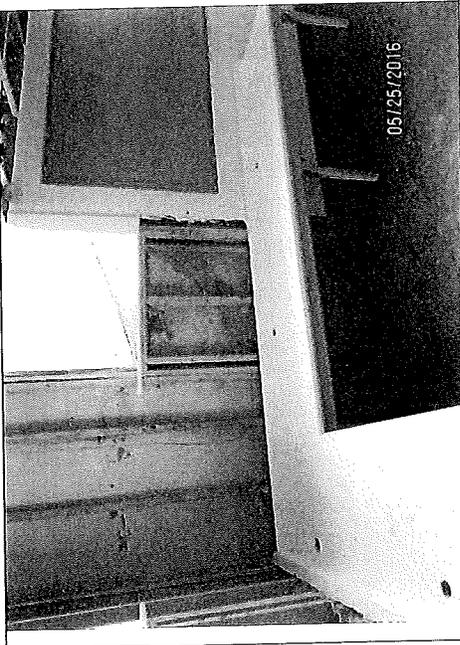
<p>05/25/2016</p>	<p><u>Location:</u> 7313 US Route 4 Bridgewater, VT</p> <p><u>Photo Taken By:</u> Richard Lalancette, P.E.</p> <p><u>IMG:</u> 1974</p> <p><u>Description:</u> Interior finish in poor condition</p>

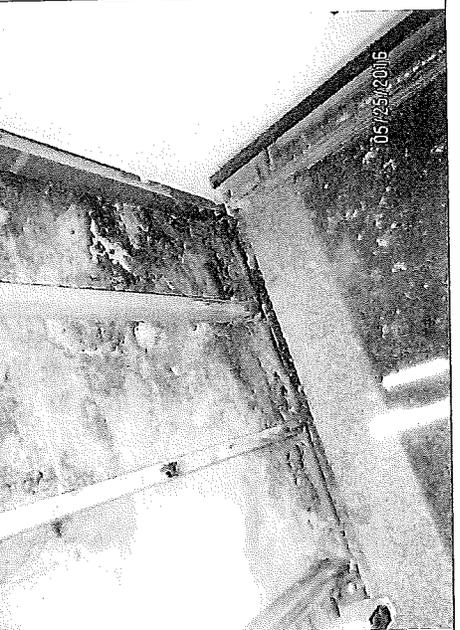
<p>05/25/2016</p>	<p><u>Location:</u> 7313 US Route 4 Bridgewater, VT</p> <p><u>Photo Taken By:</u> Richard Lalancette, P.E.</p> <p><u>IMG:</u> 1975</p> <p><u>Description:</u> Evidence of leakage in front basement</p>

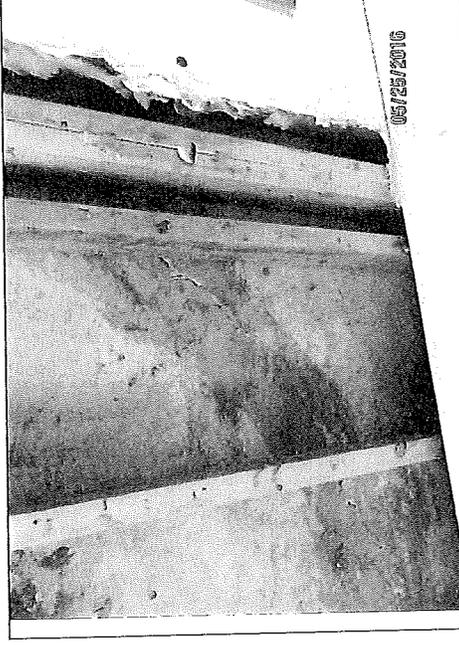
<p>05/25/2016</p>	<p><u>Location:</u> 7313 US Route 4 Bridgewater, VT</p> <p><u>Photo Taken By:</u> Richard Lalancette, P.E.</p> <p><u>IMG:</u> 1976</p> <p><u>Description:</u> Wall crack in basement</p>

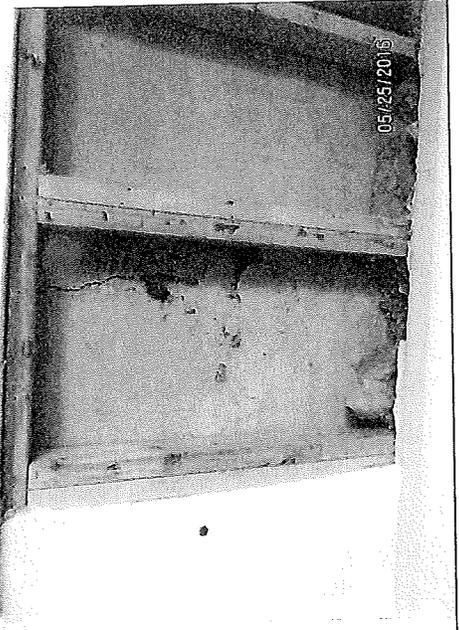
<p>05/25/2016</p>	<p><u>Location:</u> 7313 US Route 4 Bridgewater, VT</p> <p><u>Photo Taken By:</u> Richard Lalancette, P.E.</p> <p><u>IMG:</u> 1977</p> <p><u>Description:</u> Wall crack in basement</p>

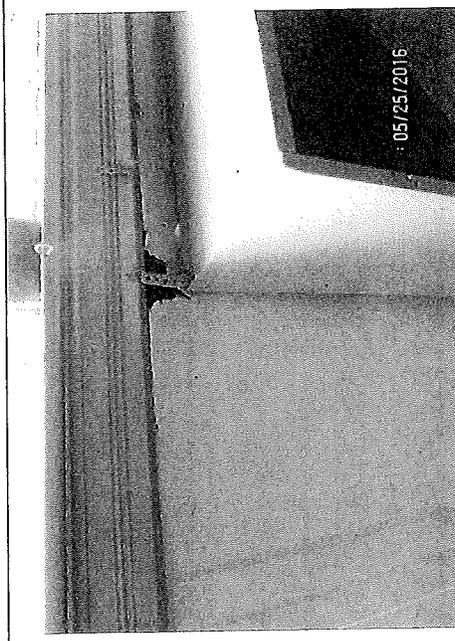
A black and white photograph showing a corner of a room. The wall is light-colored and has a large, irregular hole or missing section of plaster. A window frame is visible on the right side. A date stamp '05/25/2016' is in the bottom right corner.	<p><u>Location:</u> 7313 US Route 4 Bridgewater, VT</p> <p><u>Photo Taken By:</u> Richard Lalancette, P.E.</p> <p><u>IMG:</u> 1983</p> <p><u>Description:</u> Interior finish repair needed</p>

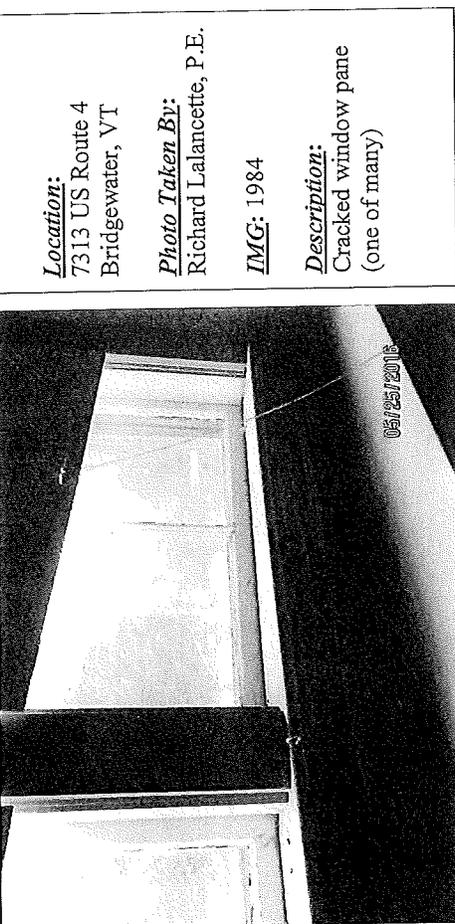
A black and white photograph of a window. The window pane is cracked and appears to be broken or severely damaged. The frame is dark. A date stamp '05/25/2016' is in the bottom right corner.	<p><u>Location:</u> 7313 US Route 4 Bridgewater, VT</p> <p><u>Photo Taken By:</u> Richard Lalancette, P.E.</p> <p><u>IMG:</u> 1984</p> <p><u>Description:</u> Cracked window pane (one of many)</p>
---	---	---	---

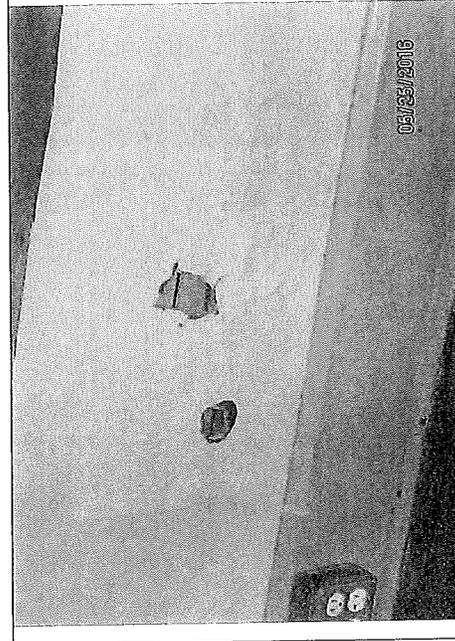
A black and white photograph of a wall. There are several holes and areas of missing plaster. One hole is particularly large and irregular. A date stamp '05/25/2016' is in the bottom right corner.	<p><u>Location:</u> 7313 US Route 4 Bridgewater, VT</p> <p><u>Photo Taken By:</u> Richard Lalancette, P.E.</p> <p><u>IMG:</u> 1985</p> <p><u>Description:</u> Plaster repair needed</p>

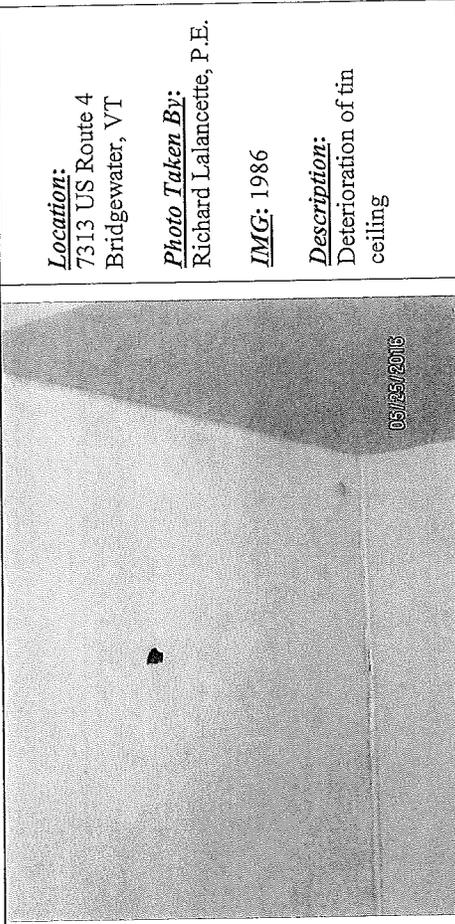
A black and white photograph of a ceiling. The surface is light-colored and shows signs of wear and deterioration, including a small dark spot. A date stamp '05/25/2016' is in the bottom right corner.	<p><u>Location:</u> 7313 US Route 4 Bridgewater, VT</p> <p><u>Photo Taken By:</u> Richard Lalancette, P.E.</p> <p><u>IMG:</u> 1986</p> <p><u>Description:</u> Deterioration of tin ceiling</p>
---	---	--	--

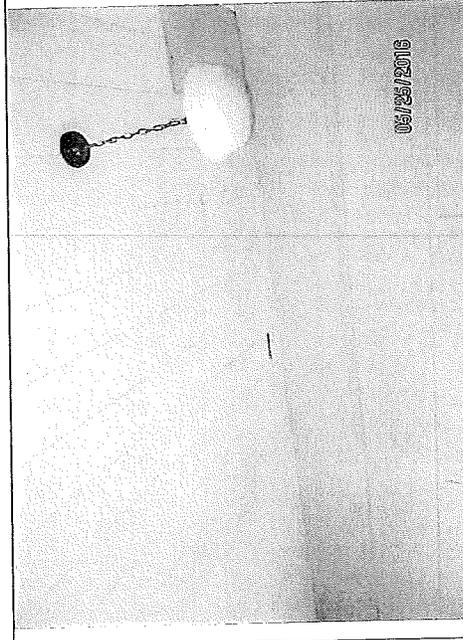
<p>05/25/2016</p>	<p><u>Location:</u> 7313 US Route 4 Bridgewater, VT</p> <p><u>Photo Taken By:</u> Richard Lalancette, P.E.</p> <p><u>IMG:</u> 1991</p> <p><u>Description:</u> Tile ceiling needs repair</p>

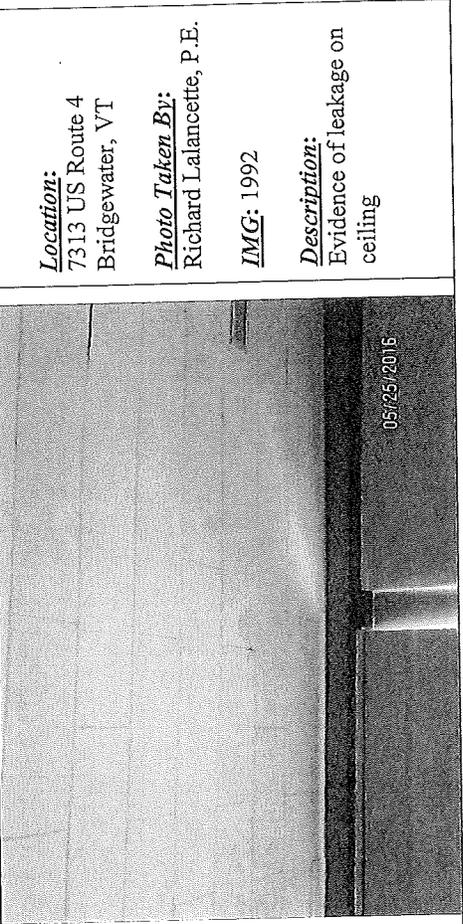
<p>05/25/2016</p>	<p><u>Location:</u> 7313 US Route 4 Bridgewater, VT</p> <p><u>Photo Taken By:</u> Richard Lalancette, P.E.</p> <p><u>IMG:</u> 1992</p> <p><u>Description:</u> Evidence of leakage on ceiling</p>
---	---	--	--

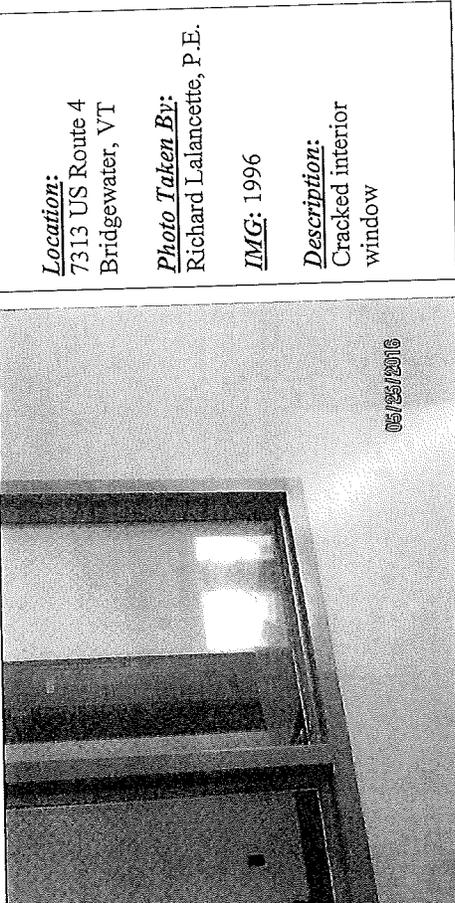
<p>05/25/2016</p>	<p><u>Location:</u> 7313 US Route 4 Bridgewater, VT</p> <p><u>Photo Taken By:</u> Richard Lalancette, P.E.</p> <p><u>IMG:</u> 1996</p> <p><u>Description:</u> Cracked interior window</p>
---	--	--	---
