To the Voters of the Town of Bridgewater:

The following is a summary regarding the future of the school building. Recall, that a survey was sent out about the possibilities. The responses and options are listed below. The town has received reports from a realtor and an engineering firm. These reports are available for your inspection at the Town Office. 142 people responded to the survey.

Summary

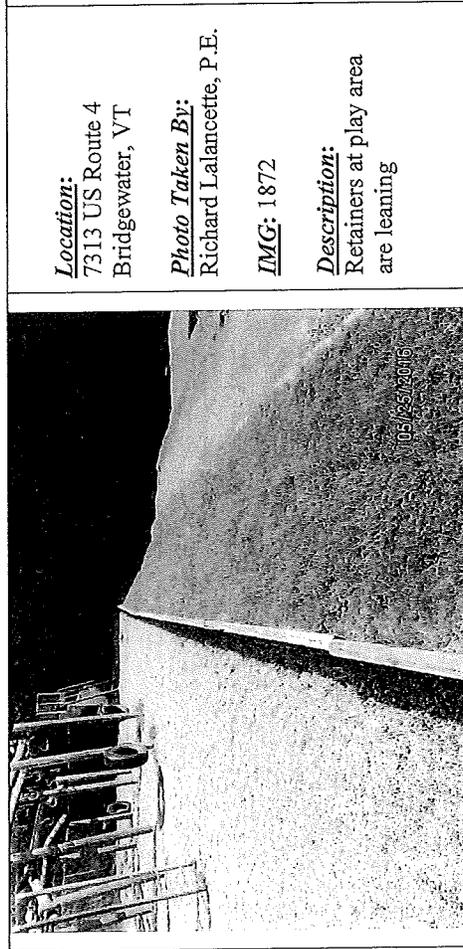
The short timber retainers at the play area are leaning and repair or replacement is needed.

<p>Location: 7313 US Route 4 Bridgewater, VT</p> <p>Photo Taken By: Richard Lalancette, P.E.</p> <p>IMG: 1872</p> <p>Description: Retainers at play area are leaning</p>

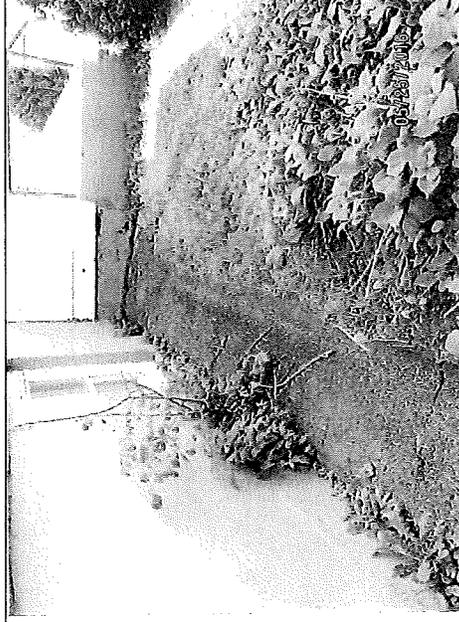
Evidence of rot and deterioration was noted in the trim at the front basement windows. This rot and deterioration may extend into the structural framing in this area. The full extent of this condition could not be determined at the time of inspection. These areas should be opened for further investigation and the proper repairs be made.

Description:
Rot in trim at front
basement windows

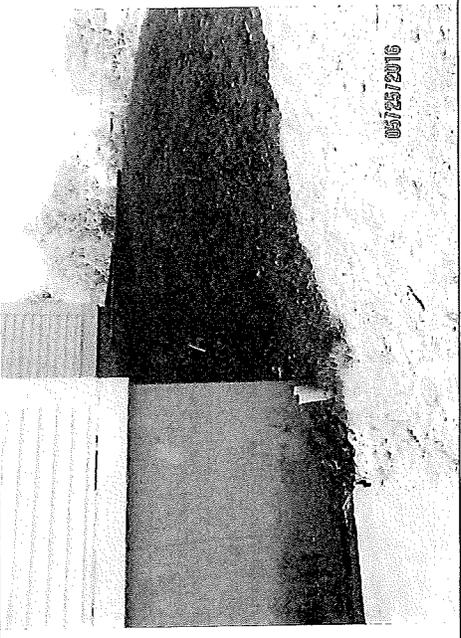
<p>05/25/2016</p>	<p>Location: 7313 US Route 4 Bridgewater, VT</p> <p>Photo Taken By: Richard Lalancette, P.E.</p> <p>IMG: 1905</p> <p>Description: Add cap at perimeter drain cleanout</p>

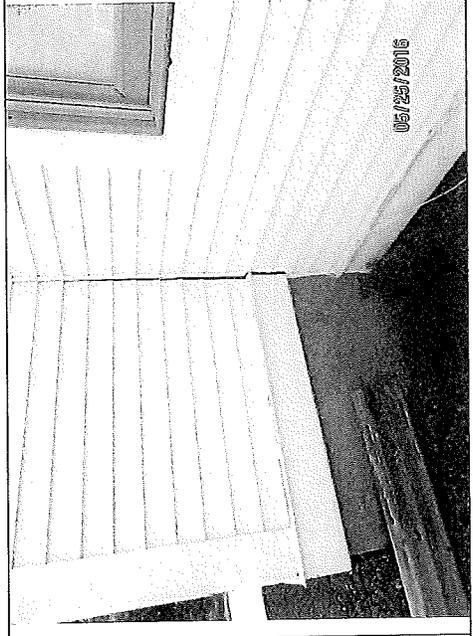
Description:
 Left rear entry has
 heaved and settled

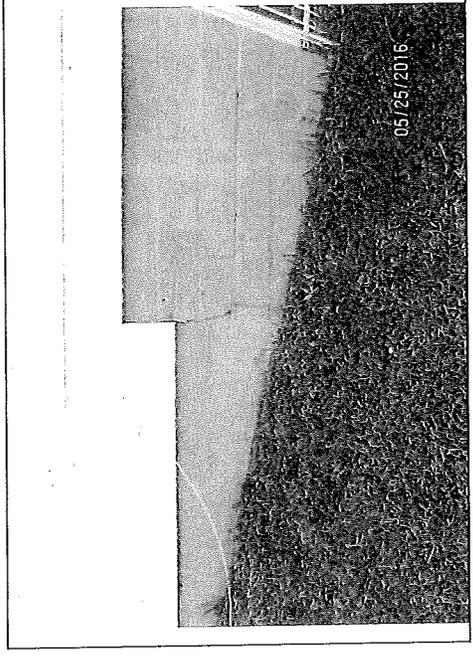
Description:
 Left rear entry has
 heaved and settled

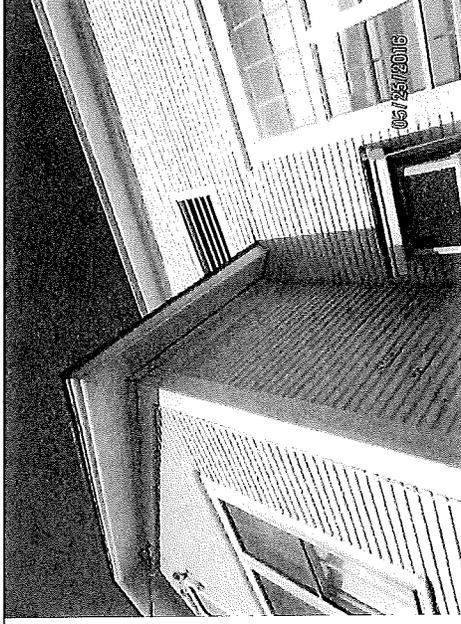
IMG: 1928

Description:
Trim spray foam
insulation

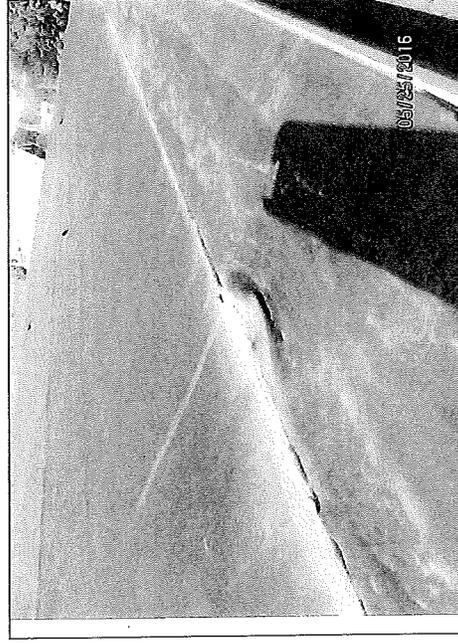
<p><u>Location:</u> 7313 US Route 4 Bridgewater, VT</p> <p><u>Photo Taken By:</u> Richard Lalancette, P.E.</p> <p><u>IMG:</u> 1933</p> <p><u>Description:</u> Seam opening on rear membrane roof</p>

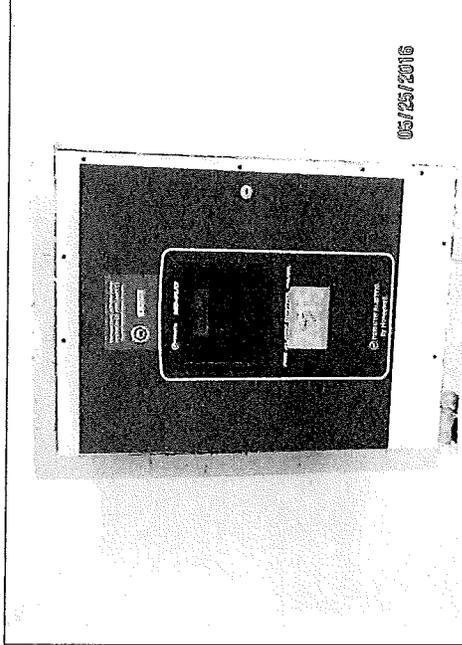
IMG: 1937

Description:
Fire alarm panel

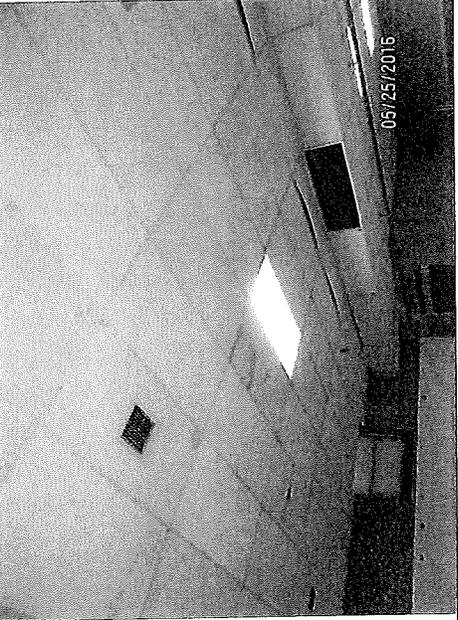
<p><u>Location:</u> 7313 US Route 4 Bridgewater, VT</p> <p><u>Photo Taken By:</u> Richard Lalancette, P.E.</p> <p><u>IMG:</u> 1941</p> <p><u>Description:</u> Leakage on ceiling at multipurpose</p>
---	---	--	--

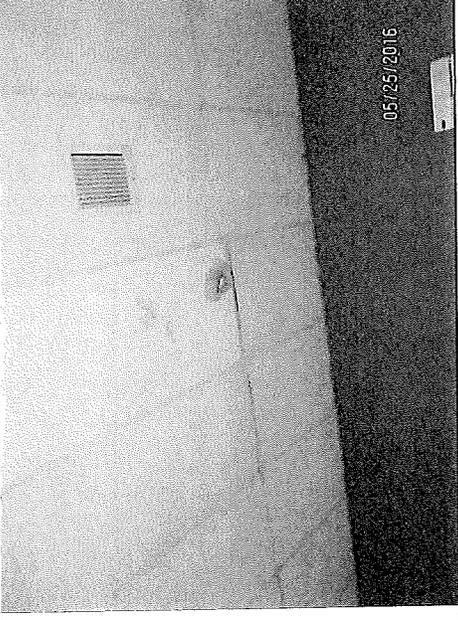
<p><u>Location:</u> 7313 US Route 4 Bridgewater, VT</p> <p><u>Photo Taken By:</u> Richard Lalancette, P.E.</p> <p><u>IMG:</u> 1943</p> <p><u>Description:</u> Leakage on ceiling at multipurpose room</p>
--	---	---	---

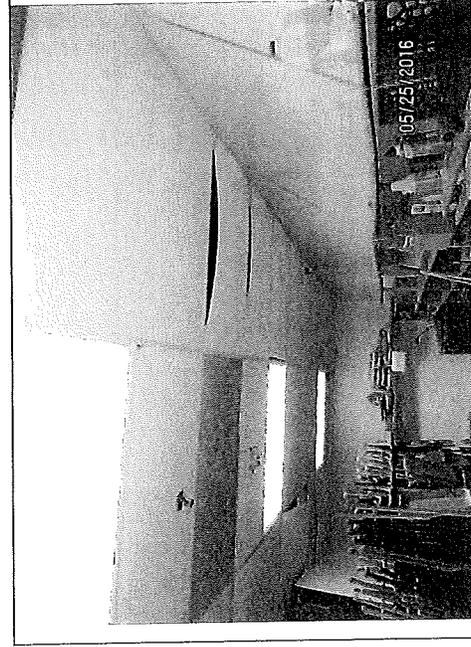
IMG: 1944

Description:
Ceiling tile repair
needed in lower storage
closet

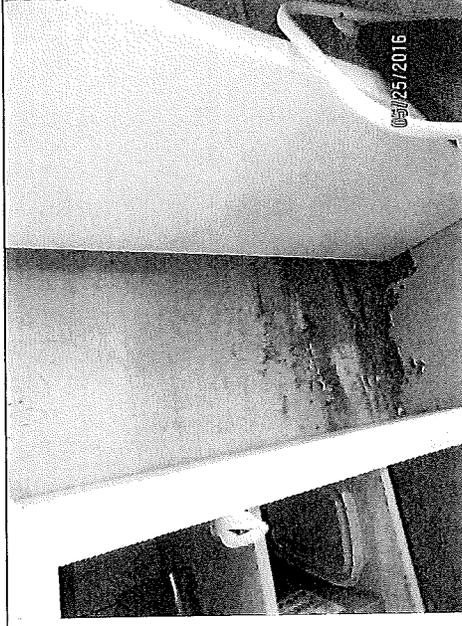
IMG: 1946

Description:
Evidence of moisture
entry in kitchen

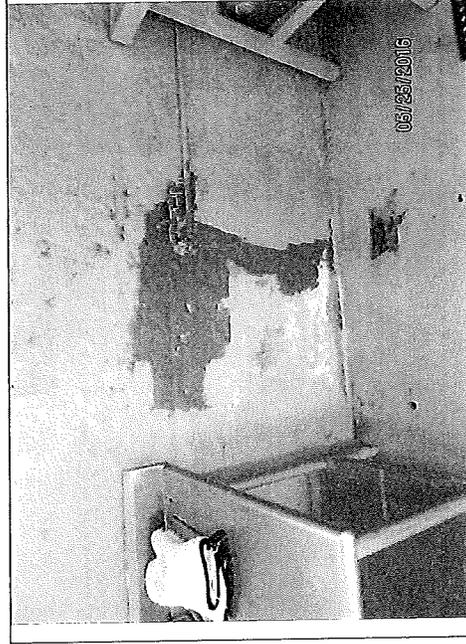
IMG: 1947

Description:
Evidence of moisture
entry in kitchen

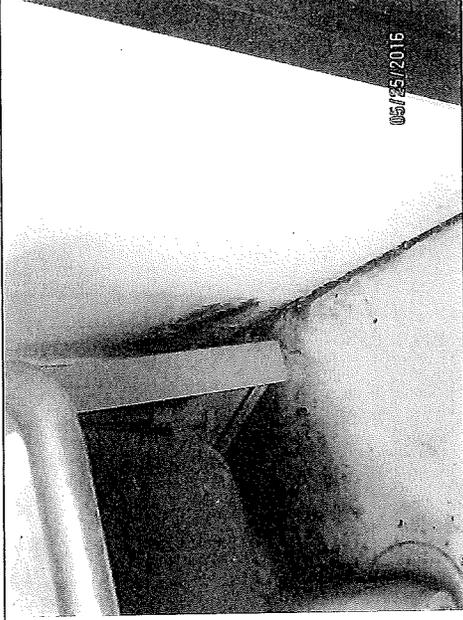
<p>05/25/2016</p>	<p><u>Location:</u> 7313 US Route 4 Bridgewater, VT</p> <p><u>Photo Taken By:</u> Richard Lalancette, P.E.</p> <p><u>IMG:</u> 1952</p> <p><u>Description:</u> Mold on wall near janitor's sink</p>

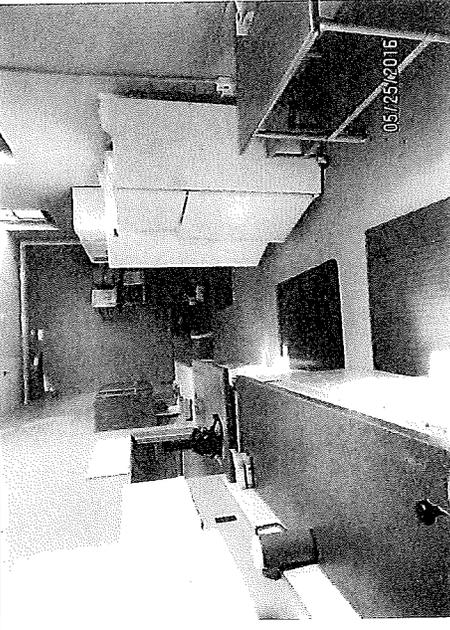
<p><u>Location:</u> 7313 US Route 4 Bridgewater, VT</p> <p><u>Photo Taken By:</u> Richard Lalancette, P.E.</p> <p><u>IMG:</u> 1956</p> <p><u>Description:</u> Kitchen area</p>

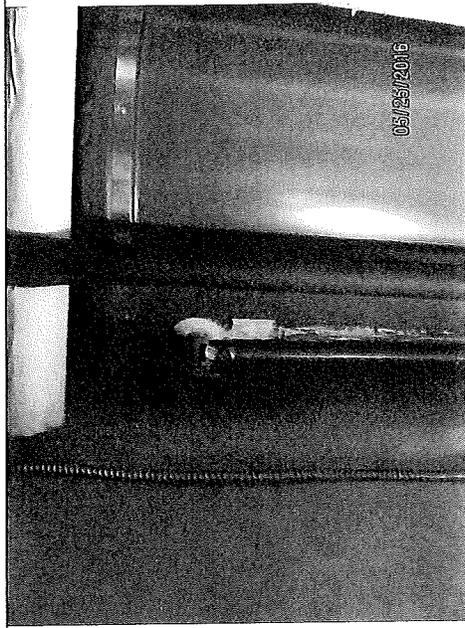
IMG: 1965

Description:
Corrosion at relief valve
on water heater

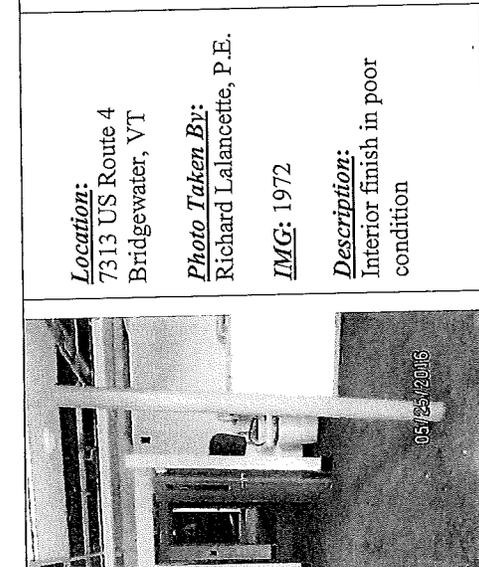
<p>05/25/2016</p>	<p>Location: 7313 US Route 4 Bridgewater, VT</p> <p>Photo Taken By: Richard Lalancette, P.E.</p> <p>IMG: 1972</p> <p>Description: Interior finish in poor condition</p>
--	--	--	---

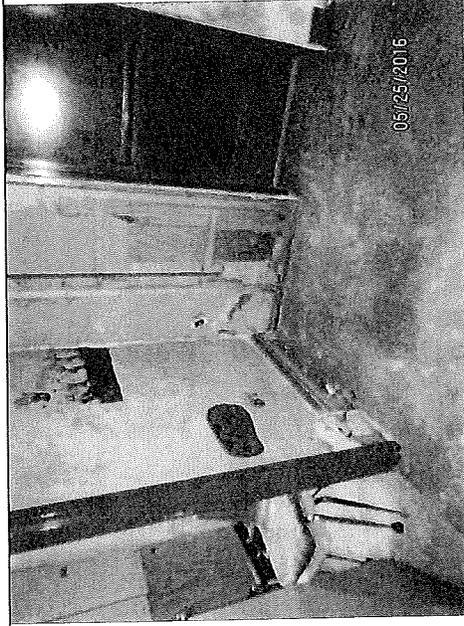
IMG: 1980

Description:
Interior finish repair
needed

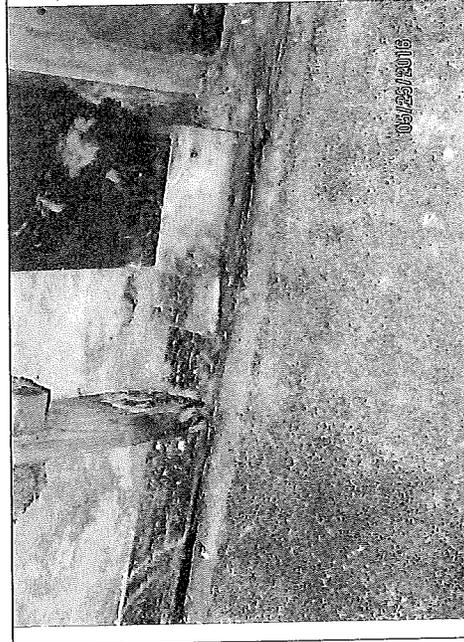
IMG: 1981

Description:
Rot in lower plate of
interior basement wall

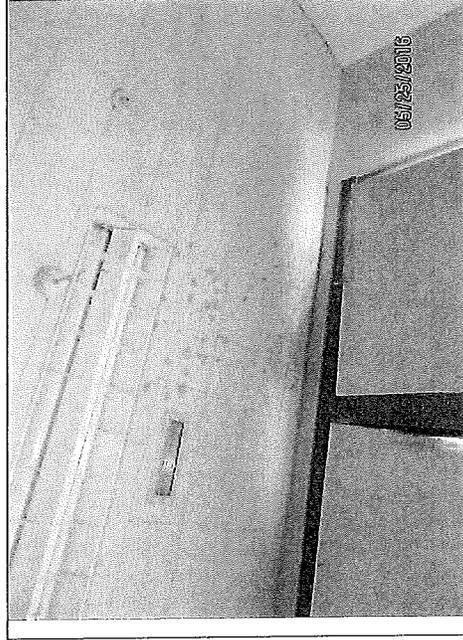
IMG: 1989

Description:
Leakage on ceiling

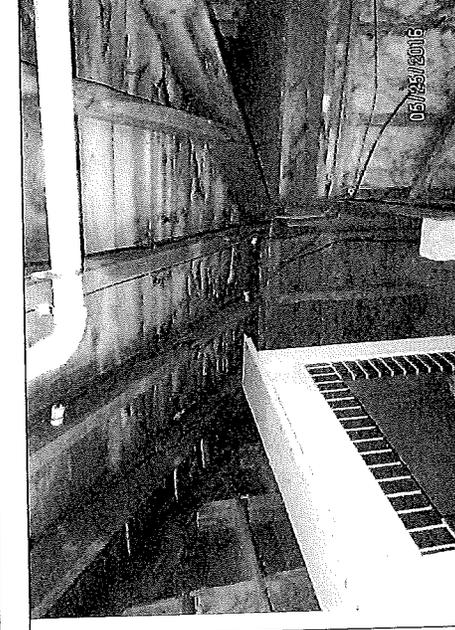
<p>05/25/2016</p>	<p><u>Location:</u> 7313 US Route 4 Bridgewater, VT</p> <p><u>Photo Taken By:</u> Richard Lalancette, P.E.</p> <p><u>IMG:</u> 1997</p> <p><u>Description:</u> Upper attic / Knob and tube wiring</p>

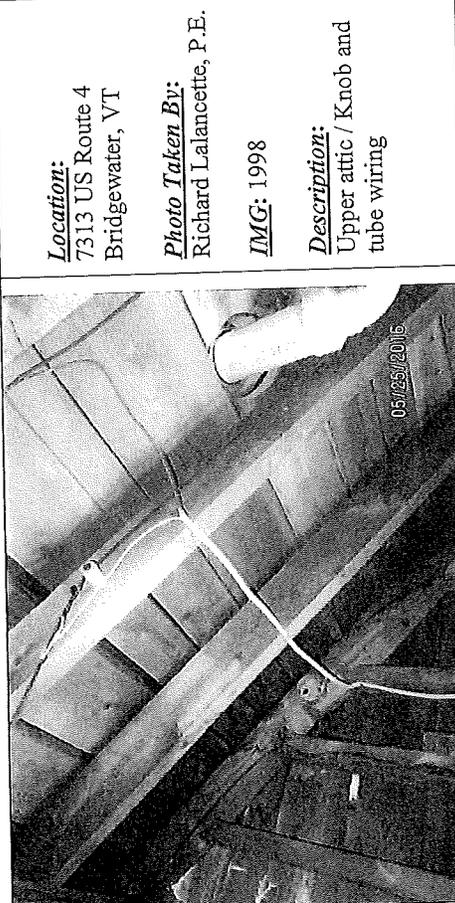
<p>05/25/2016</p>	<p><u>Location:</u> 7313 US Route 4 Bridgewater, VT</p> <p><u>Photo Taken By:</u> Richard Lalancette, P.E.</p> <p><u>IMG:</u> 1998</p> <p><u>Description:</u> Upper attic / Knob and tube wiring</p>
--	--	---	--

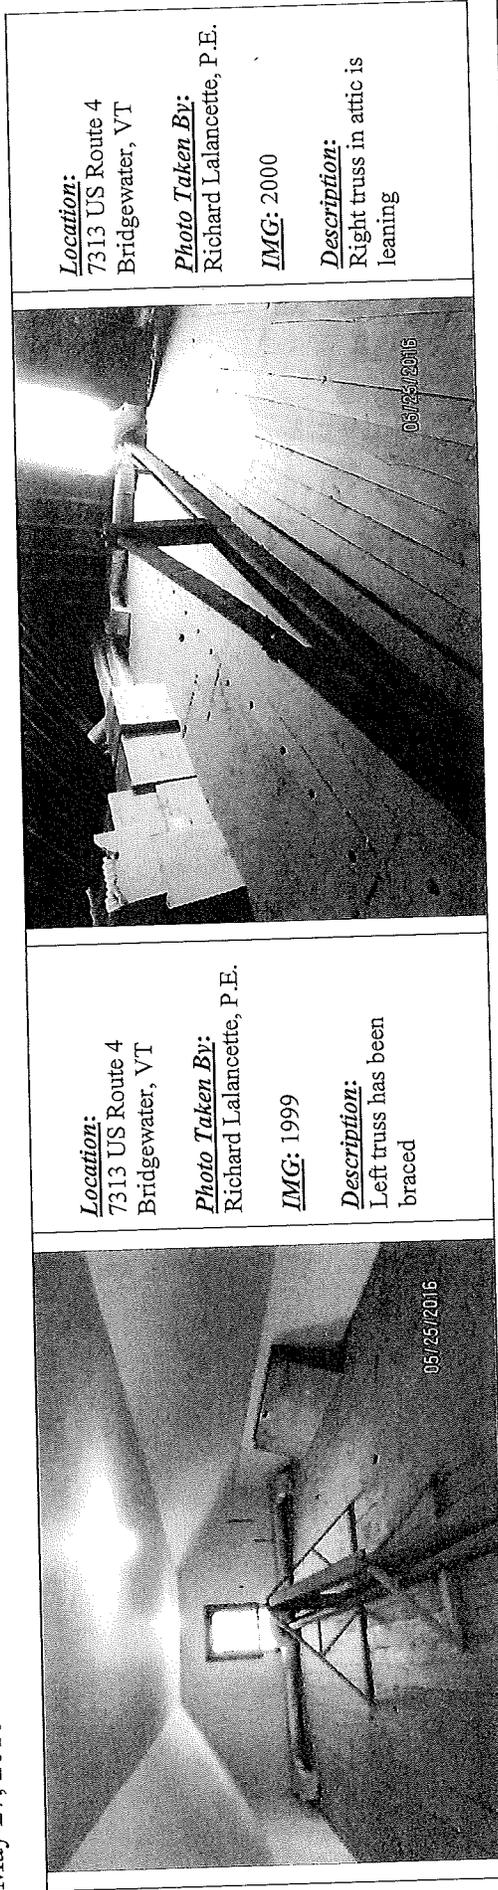
IMG: 1999

Description:
Left truss has been braced

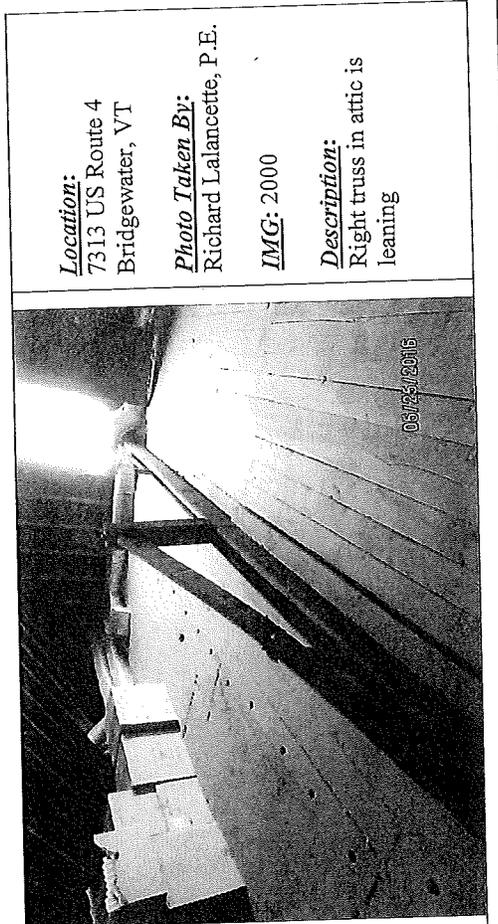
IMG: 2000

Description:
Right truss in attic is leaning

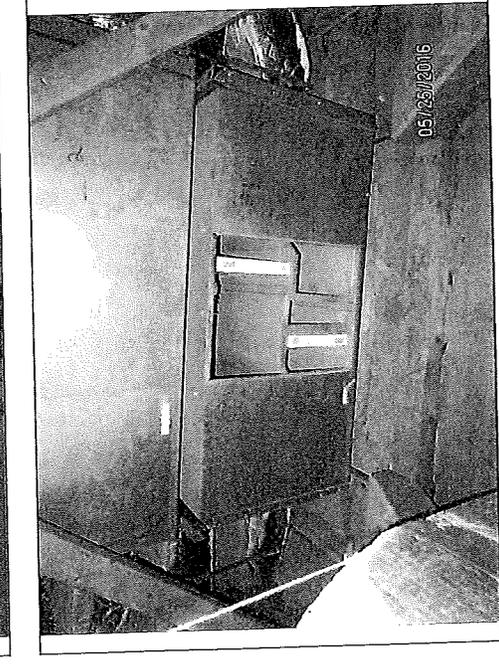
IMG: 2002

Description:
Repair air handler system in attic

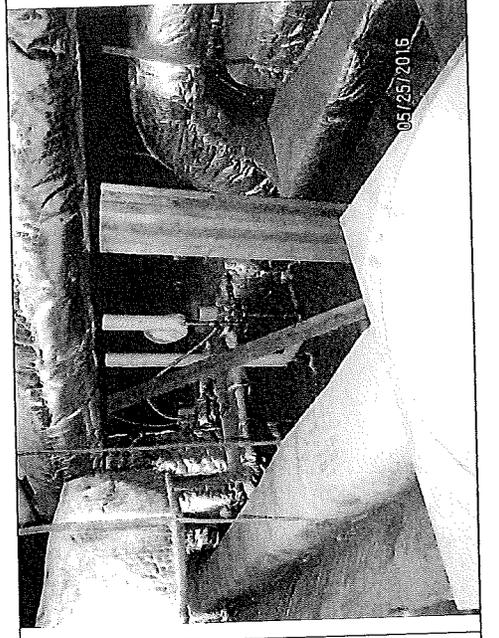
Description:
Heating coil in air handling system

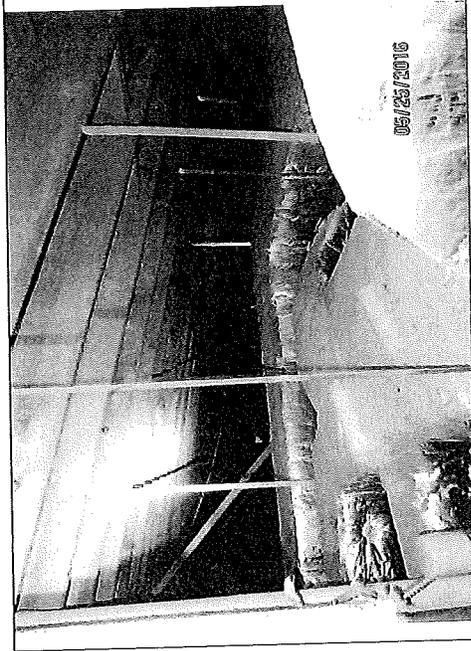
<p>05/25/2016</p>	<p><u>Location:</u> 7313 US Route 4 Bridgewater, VT</p> <p><u>Photo Taken By:</u> Richard Lalancette, P.E.</p> <p><u>IMG:</u> 2004</p> <p><u>Description:</u> Center attic</p>

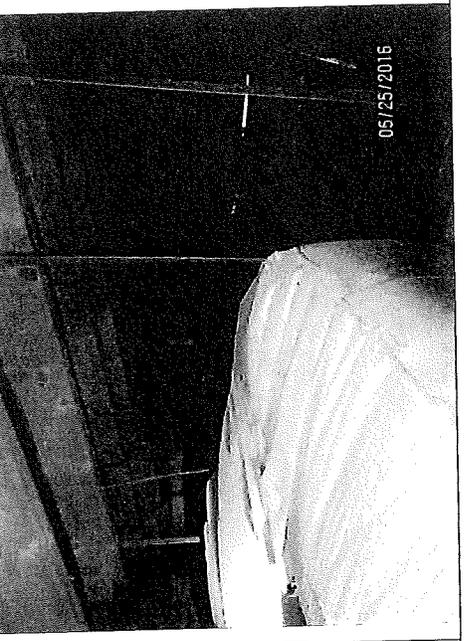
<p>05/25/2016</p>	<p><u>Location:</u> 7313 US Route 4 Bridgewater, VT</p> <p><u>Photo Taken By:</u> Richard Lalancette, P.E.</p> <p><u>IMG:</u> 2005</p> <p><u>Description:</u> Center attic</p>
---	--	--	--
